MOSS NO. 2

RUSSELL COUNTY, VIRGINIA

Inventory Number: VA. NO. 16705

PHASE I INSPECTION REPORT

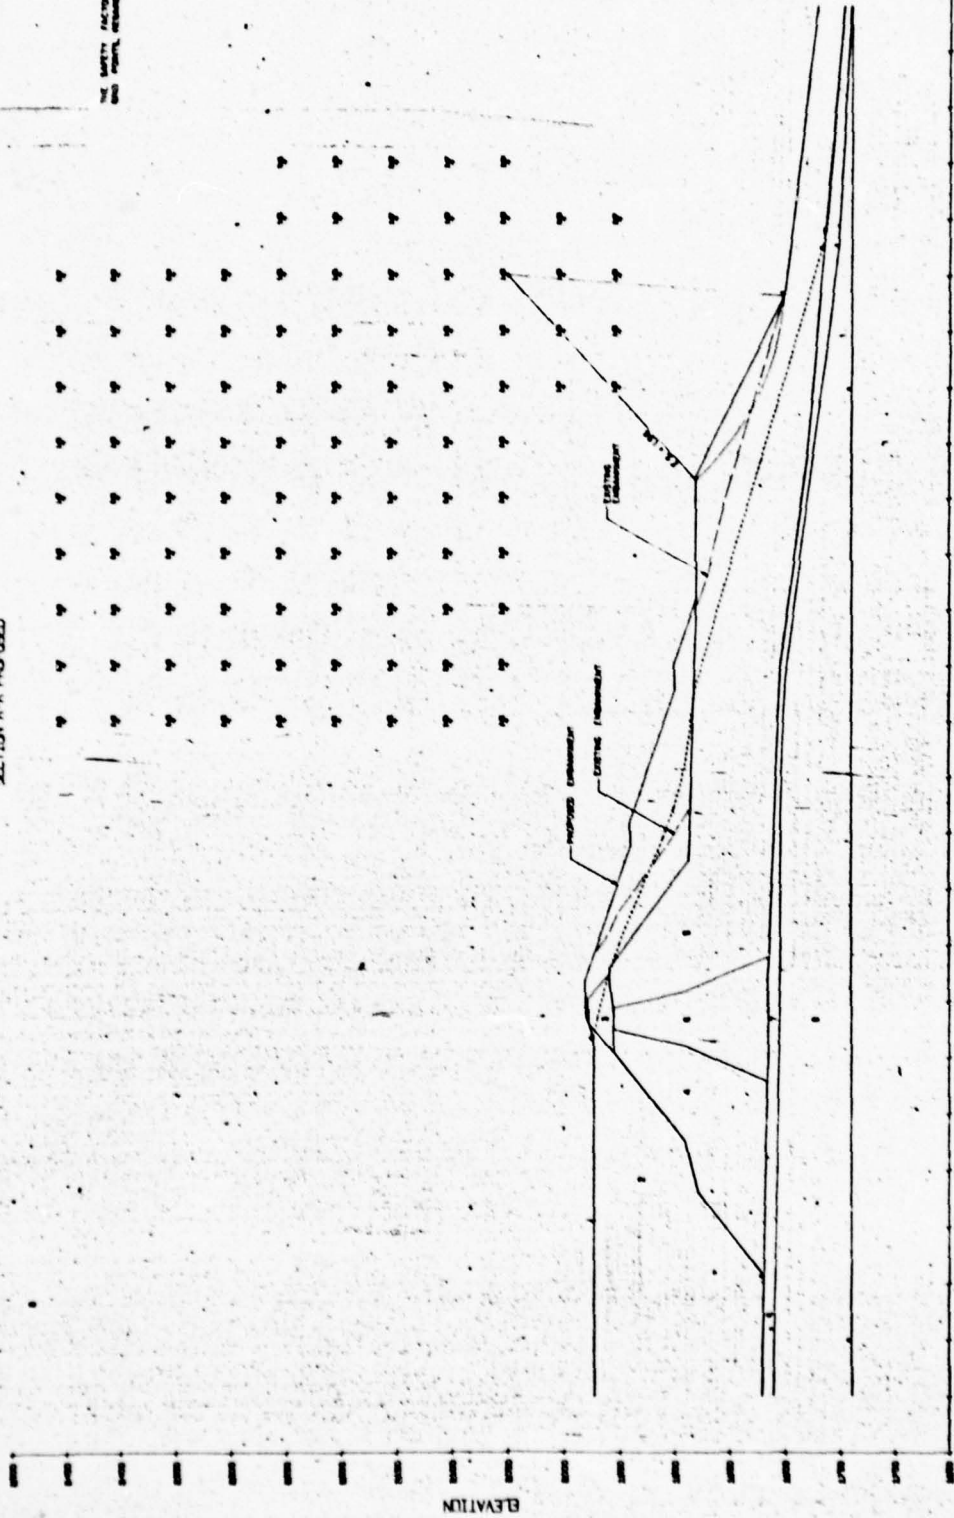
SIMPLIFIED BISPOF METHOD SECTION A-A PROPOSED

THE SAFETY FACTOR, WHICH ARE THE LOWEST AND HIGHEST OF THE
AND POINTS, REMAINS OF THE LOWEST AND HIGHEST
